Manhole Inspection Summary

Manhole # S21II_033MH

Insp Date: **6/22/07 12:03 PM**

Location Address: **1700 MCKEAN-FULTON** Cross Street: **PRESBURY ST**

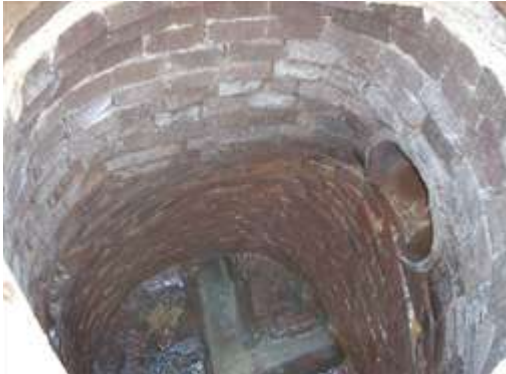
Defect 4

Comments **major infiltration of barrel, huge hole on corbel**

Barrel Material: **Brick** ☐ Parged
Shape: **Circular** Diameter: **46** (in.) Length: (in.)
Condition: ☒ Sound ☐ Cracked ☐ Root Intrusion ☐ Loose Brick ☐ Deteriorated
Infiltration: ☐ None ☒ **Joint** ☐ Cracks ☐ Mortar ☐ Roots ☐ Wall

MAJORBARREL INFILTRATION

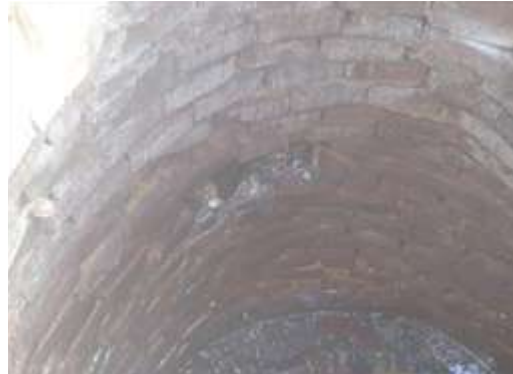
Defect 3

Corbel Material: **Brick** ☐ Parged Type: **Concentric/Eccentric**
Condition: ☐ Sound ☐ Cracked ☐ Root Intrusion ☐ Loose Brick ☒ **Deteriorated**
Infiltration: ☒ None ☐ Joint ☐ Cracks ☐ Mortar ☐ Roots ☐ Wall

CORBEL DETERIORATION(HOLE)

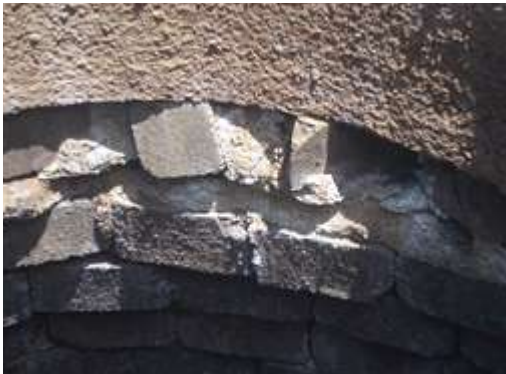
Defect 2

Chimney / Frame Adjustment ☒ Exists Material: **Brick** ☐ Parged Height: **3** (in.)
Condition: ☐ Sound ☐ Cracked ☐ Root Intrusion ☐ Loose Brick ☒ **Deteriorated**
Infiltration: ☒ None ☐ Joint ☐ Cracks ☐ Mortar ☐ Roots ☐ Wall

CHIMNEY DETERIORATION

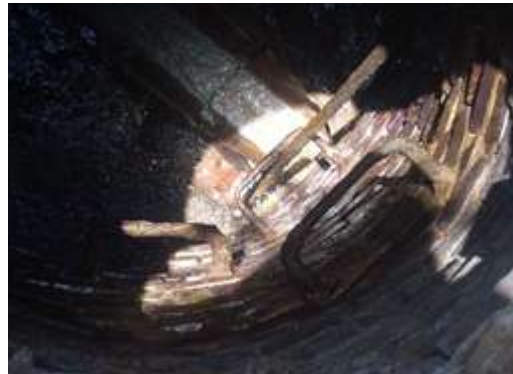
Defect 1

Steps Count: **3** Missing: **1** ☒ **Corroded**

CORRODED STEPS

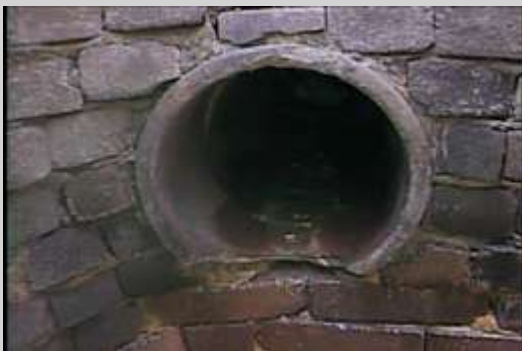
3 O'Clock Inflow

Pipe Height: **9.6** (in.) Rod and Bar (Angled)
Pipe Material: **Clay** ☐ Pipe Lined
Invert Depth: **3.28** (ft.) Flow Characteristics: **Fast**
Deposits: ☒ None ☐ Mud ☐ Sludge ☐ Debris ☐ Grease
Silt Depth: (in.) Deposits Extent:
Infiltration: **None** Pipe Seal Cond: **Broken**
